# Utilities Management Report

Operational reference, asset  
condition and forward  
maintenance priorities

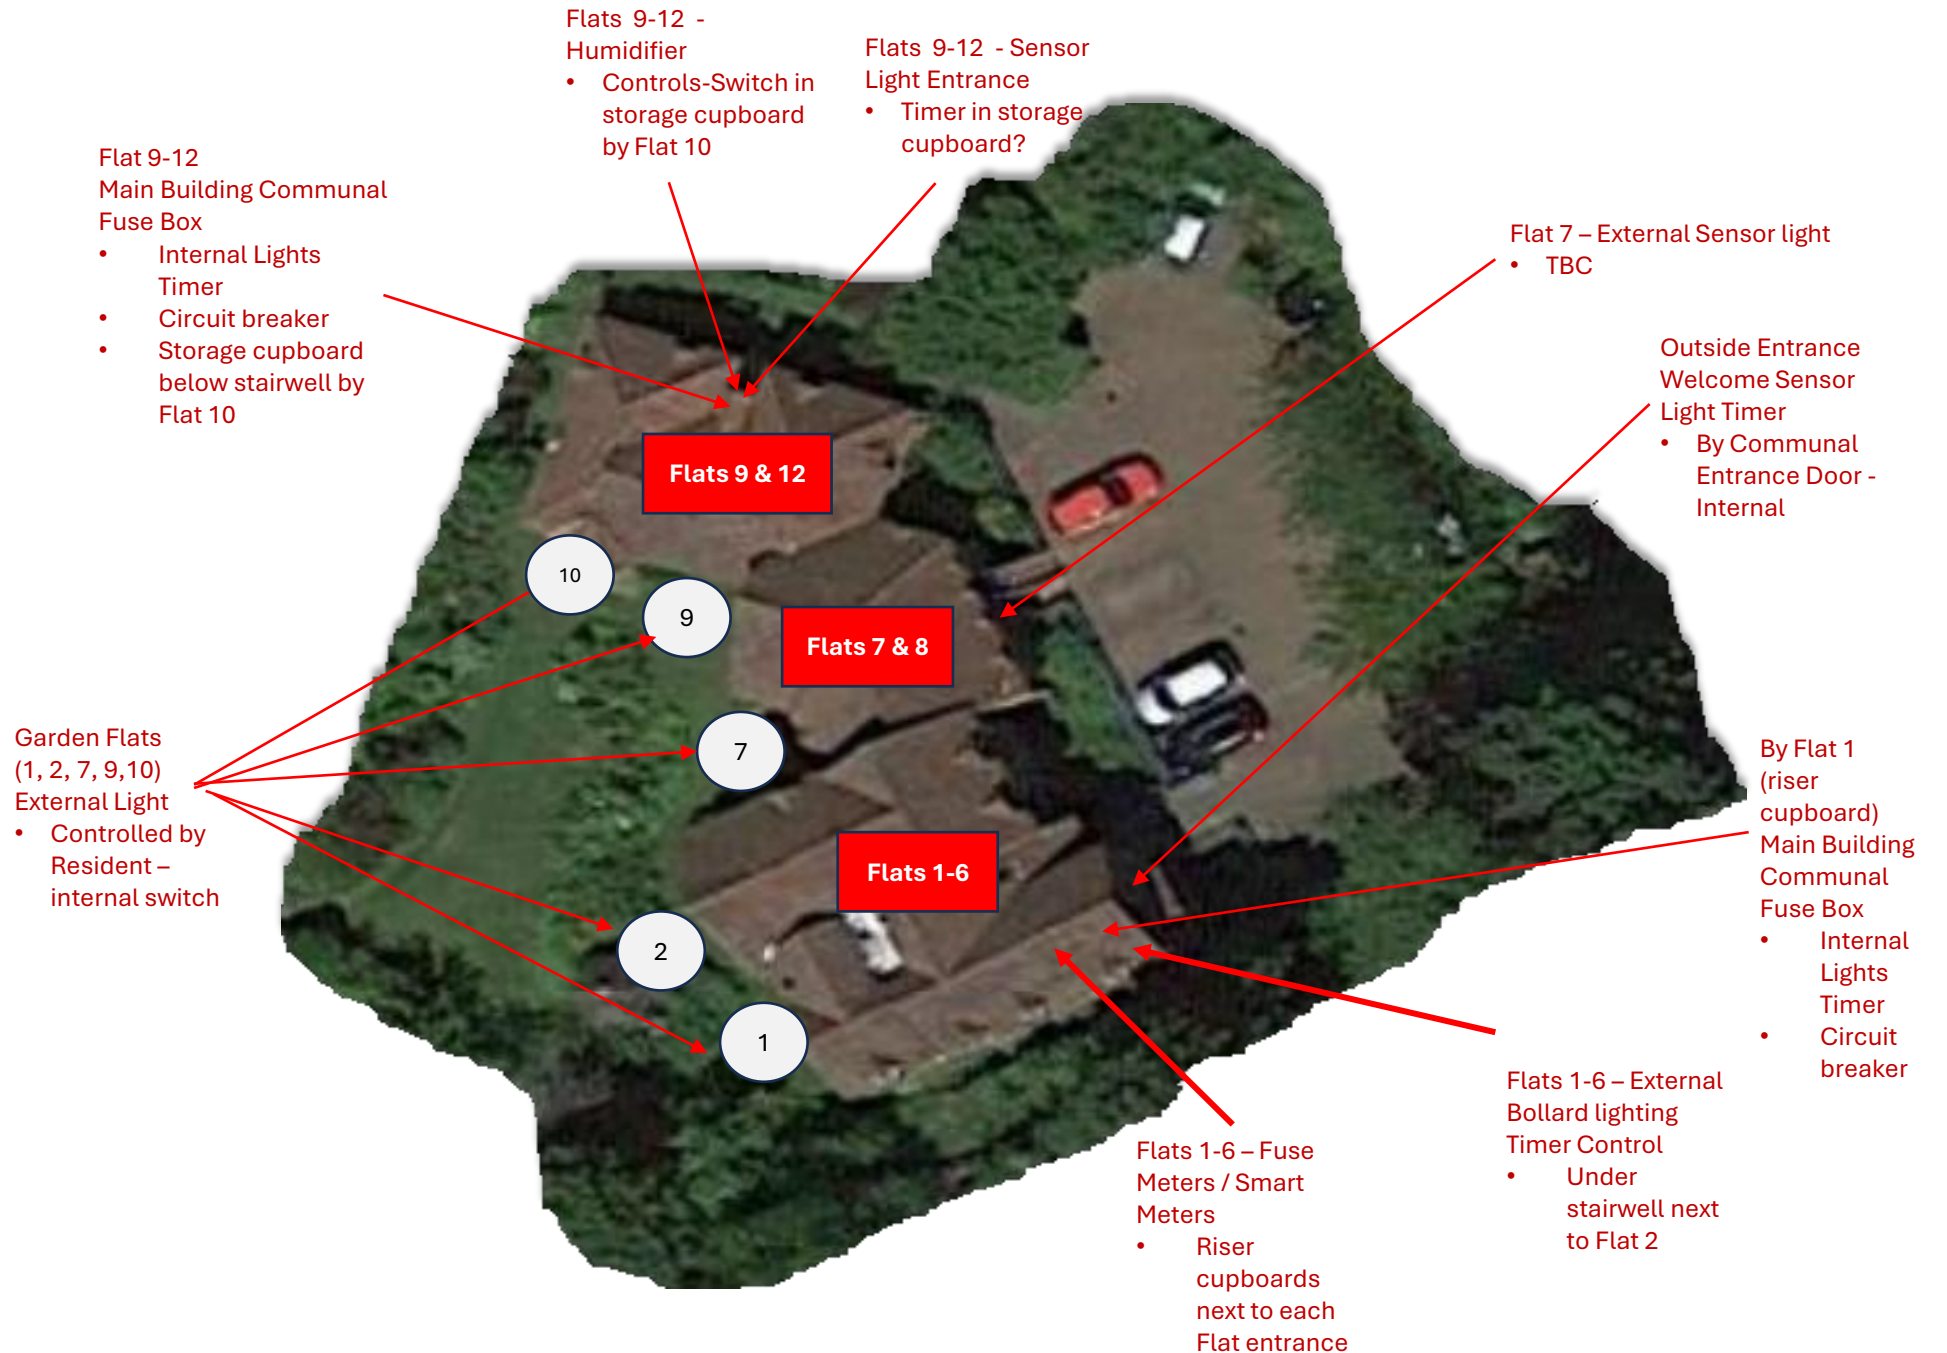
1. Flats 1, 2, 7, 9, & 10 internal light switch for external Patio Light
2. Flats 1-6 communal Fuse Box located in Flat 1 riser cupboard
3. Flats 1-6 internal communal lighting timer control located in Flat 1 riser cupboard
4. Flats 1-6 outside entrance welcome light sensor timer located by entrance door, believe there is a timer for this in storage cupboard under stairwell by Flat 10

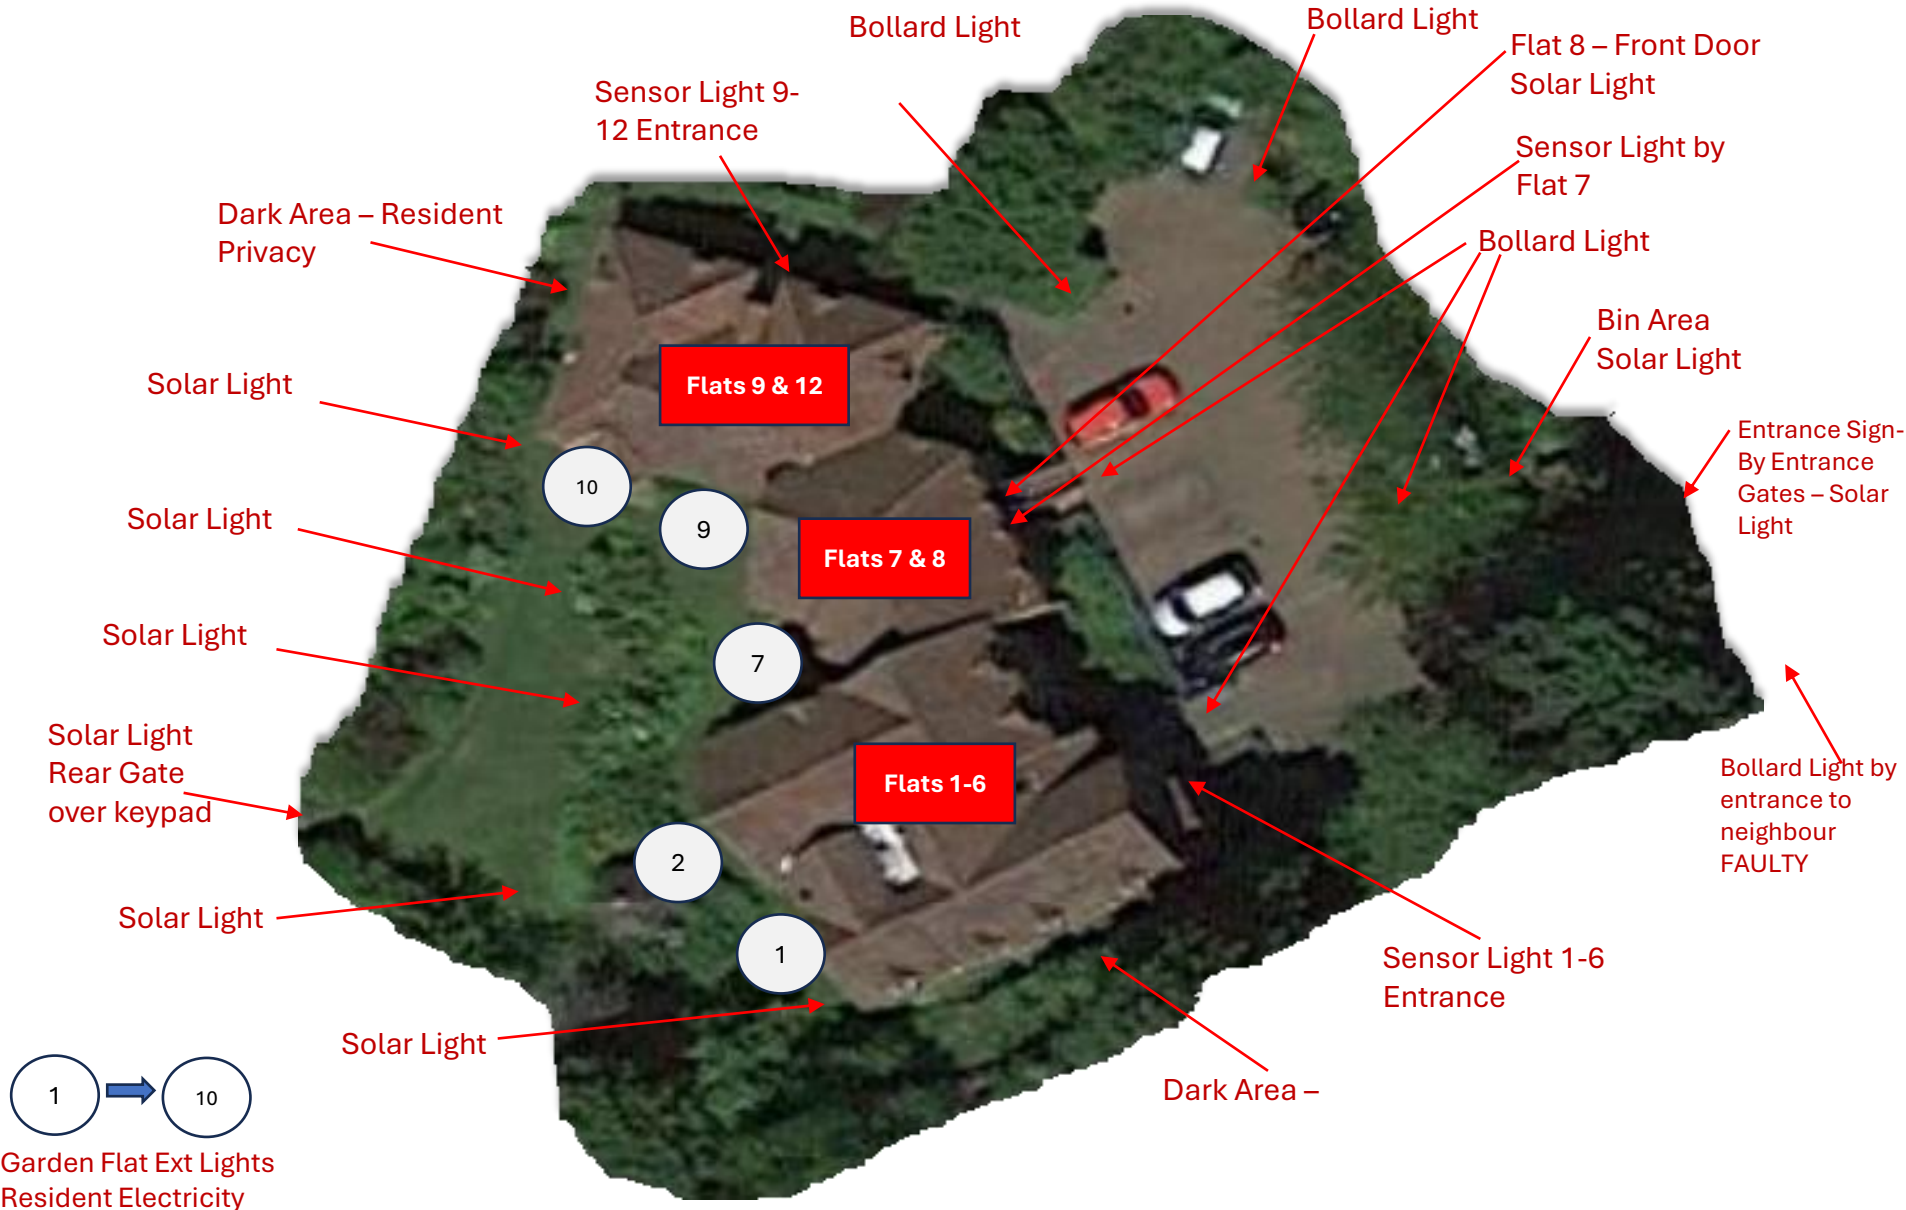
1. 9 Solar lights currently in operation around Beaufield Gate
2. Garden Flat external patio lights need upgrading ( 5 flats)
3. 6 bollard lights, 1 faulty
4. Sensor light by entrance to flats 9-12 comes on day or night
5. Timer switch for bollard lights could not be situated in a worse place
  1. *In the past bollard lighting has not been adjusted causing unnecessary waste of electricity and risking safety of residents*
6. 6.Timer switch for welcome light at entrance to Beaufield Gate is located inside by entrance door

| <b>HIGH</b> | <b>External lighting</b> | One bollard reported faulty; Flats 9–12 entrance sensor operates day and night. | Electrical contractor to fault-find cabling / controls and confirm safe operation. |

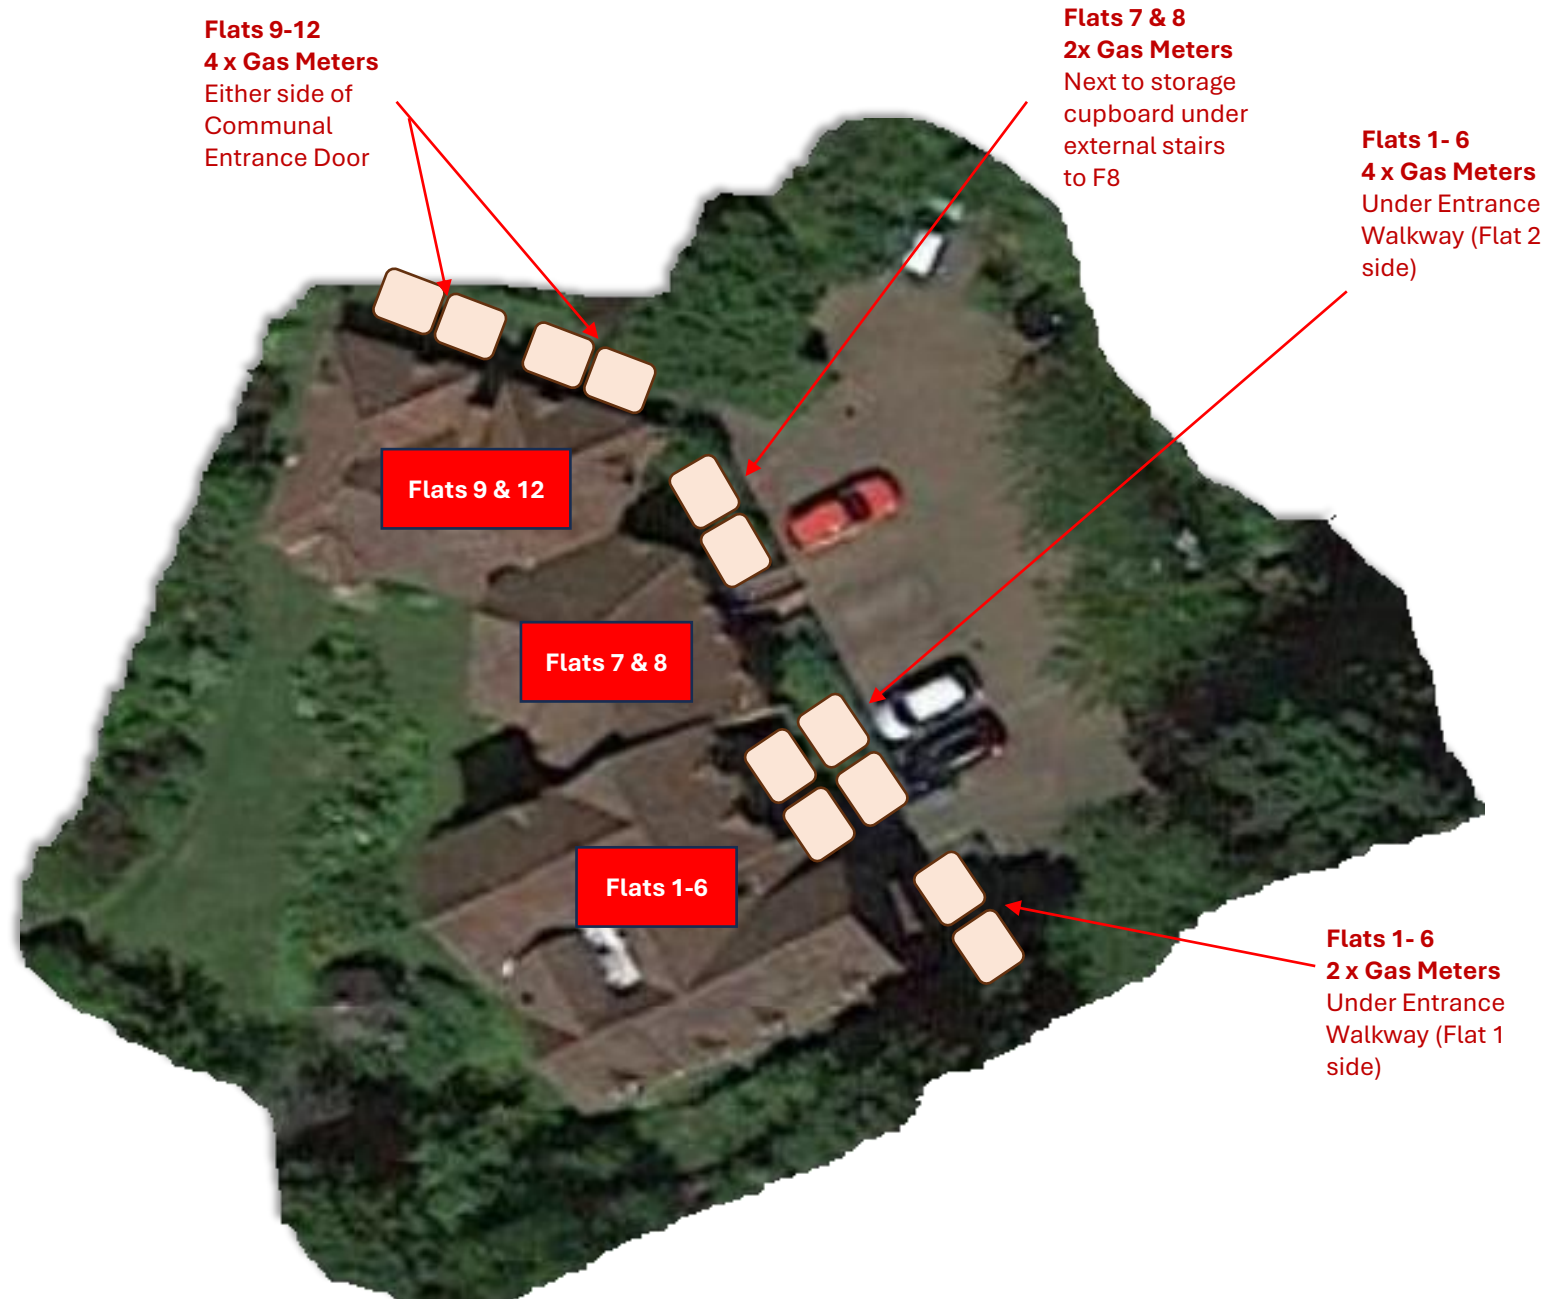
1. Flats 1-6 Meters are challenging to reach as some under elevated walkway bridge
2. Waste has been disposed under walkway (old gas meter, ladder, cone, large pipe)
3. There is no identification visible to gas engineers on which meter belongs to which flat
4. Water & Home heating runs off Gas
5. Cookers and ovens are electric

- Remove obstructions beneath the Flats 1–6 walkway.
- Verify which meter serves each flat before fitting durable labels.
- Keep meter areas clear for emergency and supplier access.
- Retain photographs as part of the asset register.

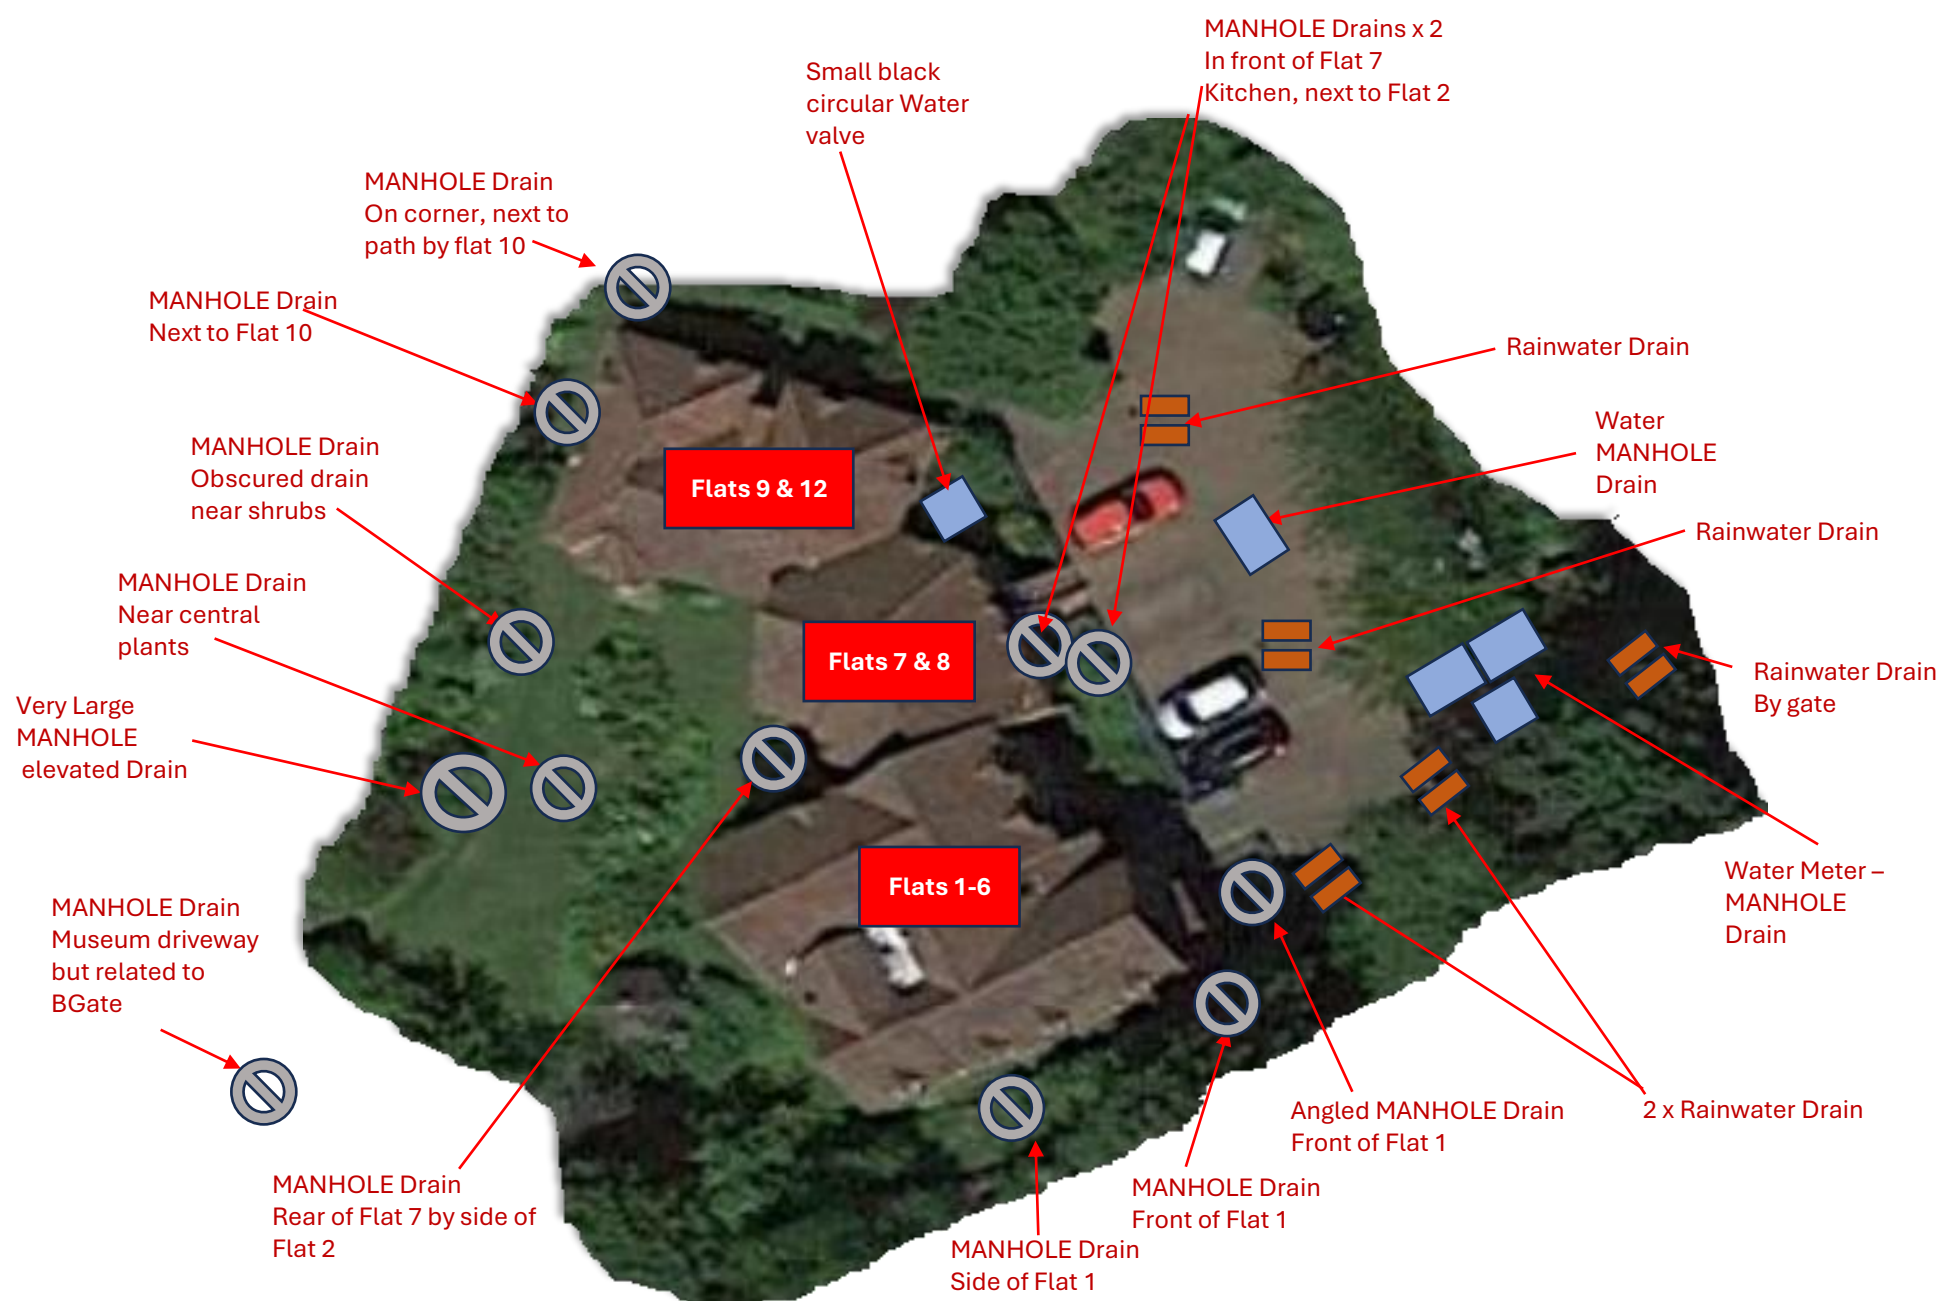
1. All Flats are connected to water meters
2. There are 12 Manhole drains
3. There are 5 water manholes / valve pipes (2 seen, may be more)
4. There is no independent external tap, cost to install with Thames Water is prohibitive
5. Manhole drain situated on museum driveway is at risk from bamboo plants roots on Museum grounds
6. There is an issue with some flats hearing gurgling sounds from sinks/basins, and overflow of water from neighbour baths (this could be an internal drain issue)

Jet / clean accessible drainage.  
Record chamber condition and flow route.  
Investigate reported internal symptoms.  
Confirm ownership / responsibility for off-boundary chamber.
